LANDSLIDES AND RELATED FEATURES

OF THE NANTY GLO, PA. QUADRANGLE

by
John S. Pomeroy
1979

OPEN FILE MAP 79-1314 (D-10)

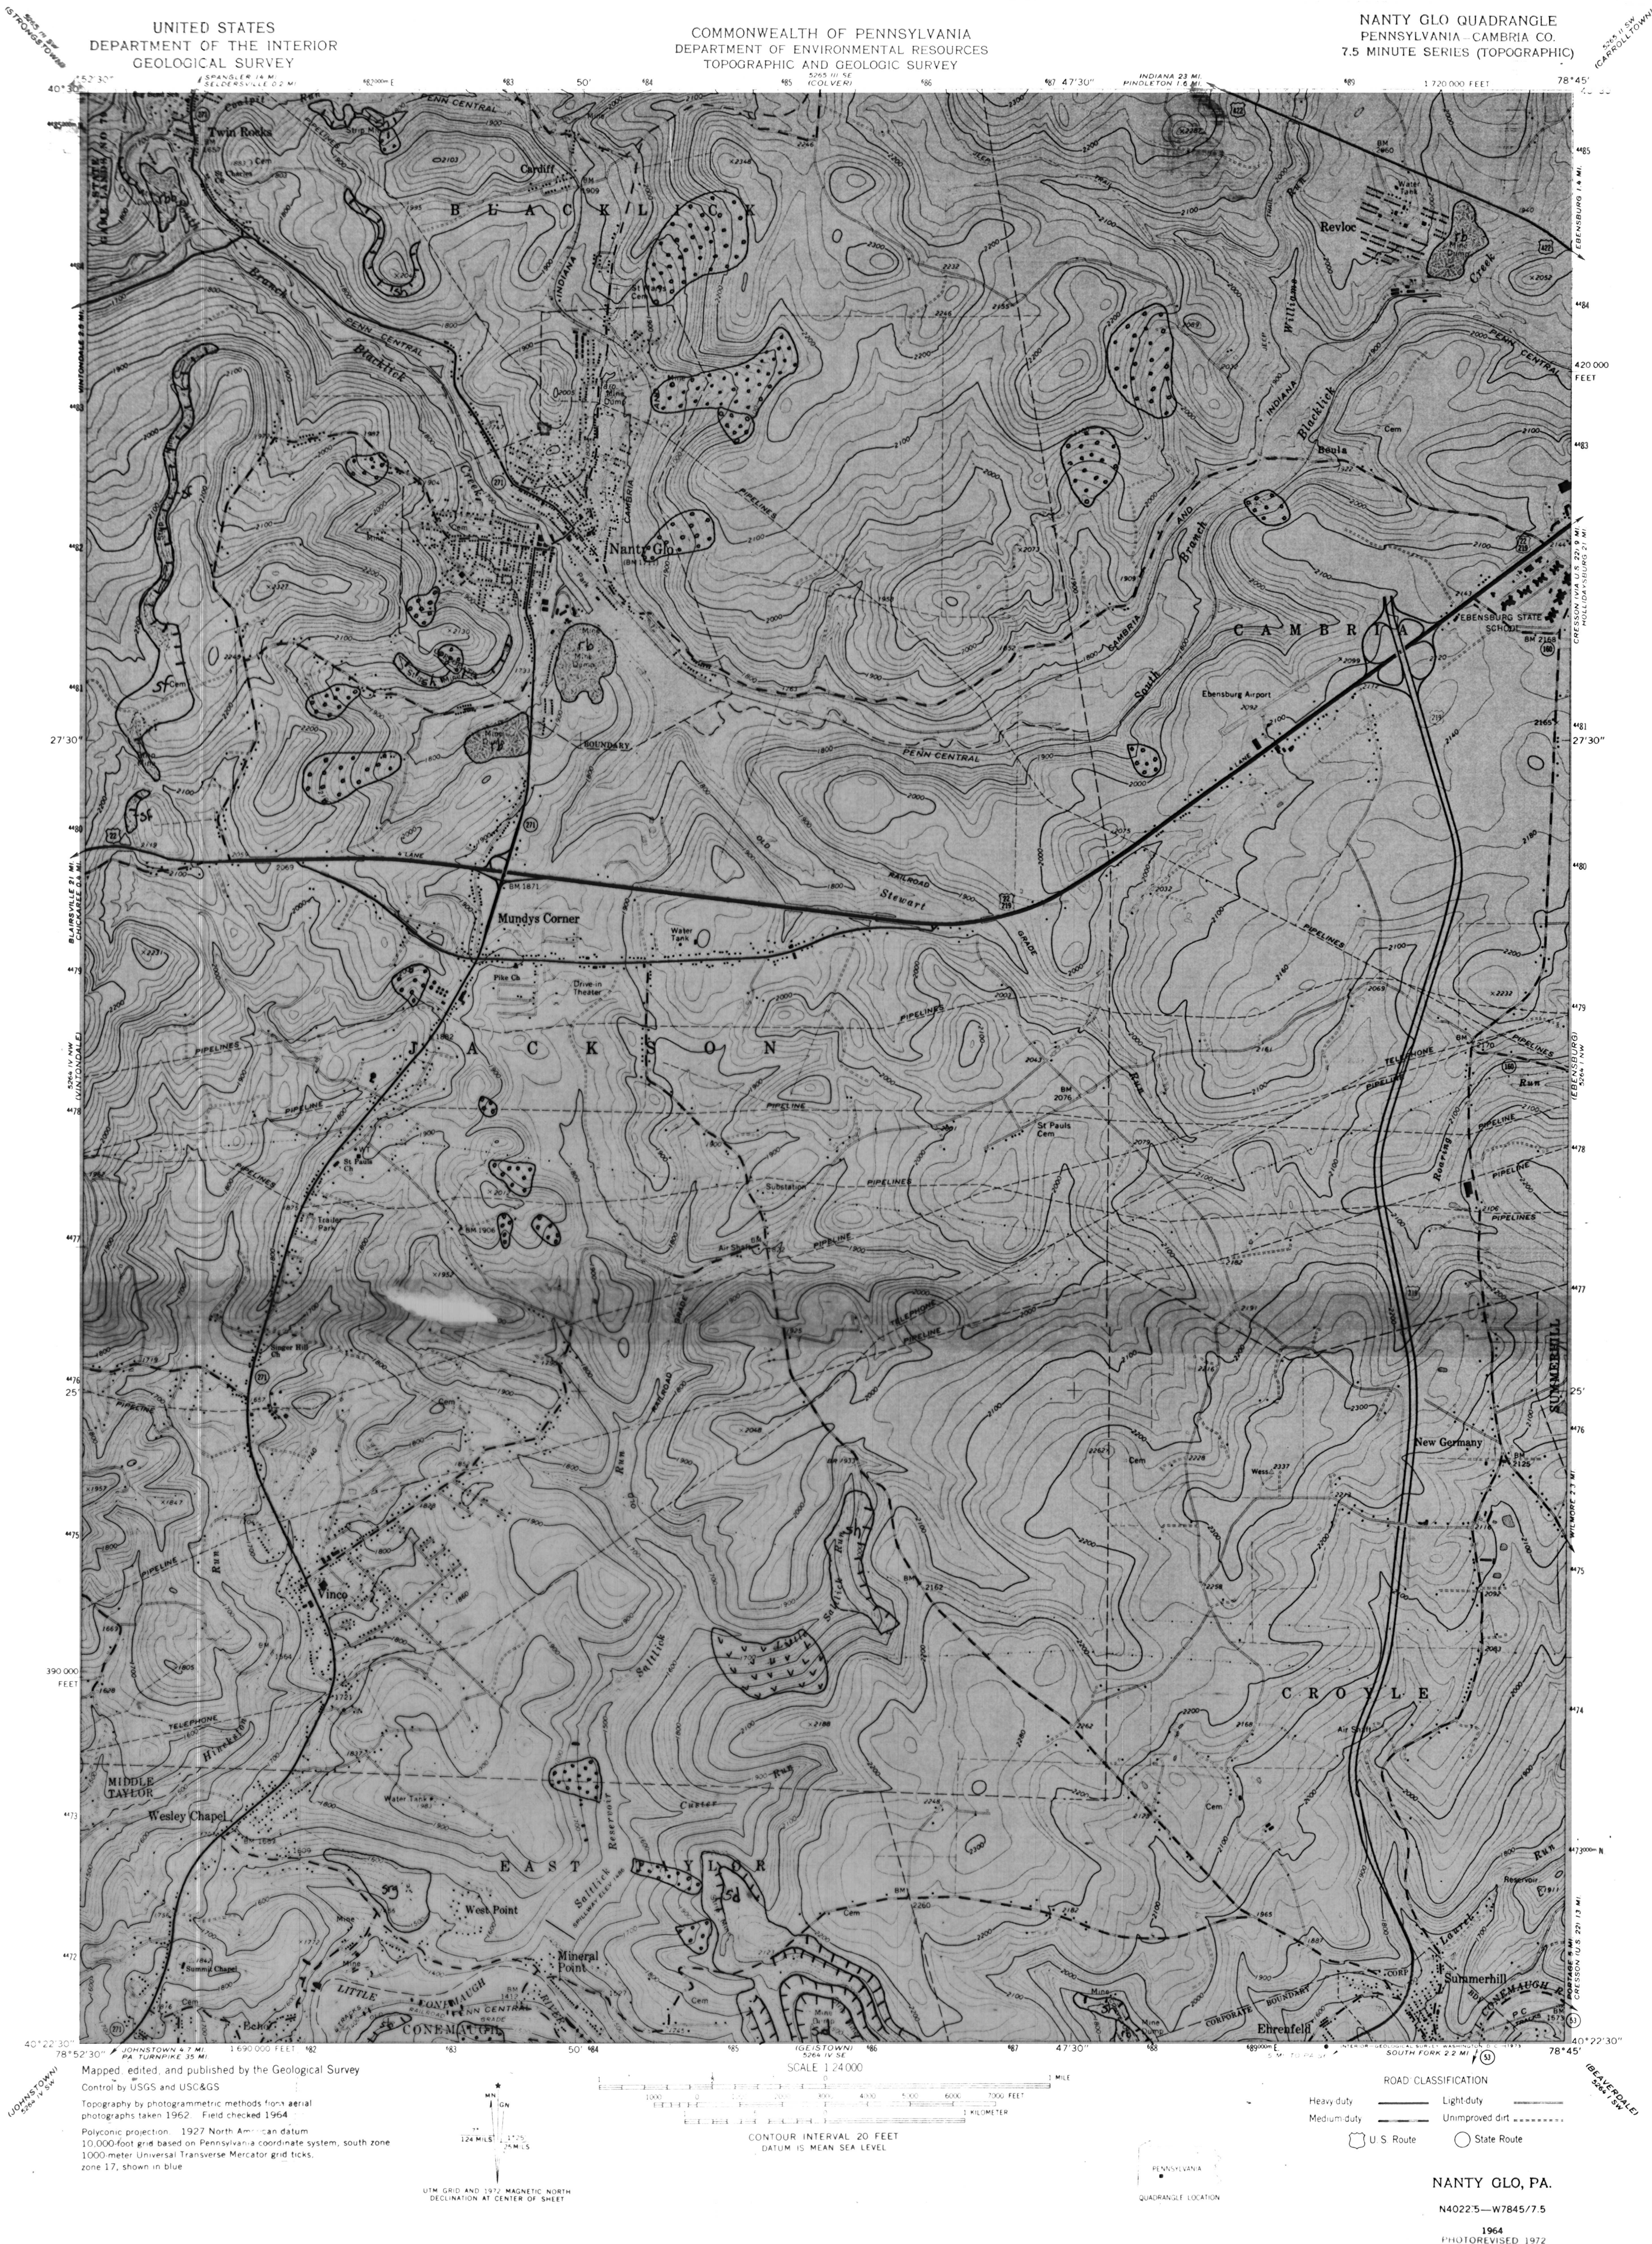
Landslides and related features interpreted
from aerial photographs:
1:78,000 (black and white) 1977

Photointerpretation and field check 1977
This map has not been edited or reviewed
for conformity with Geological Survey
standards and nomenclature.

ACTIVE OR RECENTLY ACTIVE LANDSLIDE
Complex landslide composed of earthflow, debris
slide, earth and rock slump. Identified from
historical records, and from scars, debris and
other field evidence. Ground extremely unstable;
sliding accelerated by excavation, loading and
changes in drainage conditions. May include
areas with several active slides too small to
be shown separately. Questioned where doubtful.
Includes 1977 undifferentiated storm-induced
mass movement in Johnstown area.

OLD LANDSLIDE
Area of extensive hummocky ground caused by
earthflow and earth and rock slump. Lacks
clear evidence of active sliding. Relatively
stable in natural, undisturbed state,
generally not affected by small structures properly
sited in areas away from the edge of the toe;
can be reactivated by extensive, rapid exca-
vation, loading, and changes in ground water and
surface water conditions. Area of old landslide
probably includes recent ones not identified
from field evidence or otherwise documented.
Upslope boundary of landslide generally defined
by modified scarp, but downslope (toe) may be
gradational and not well defined. Questioned
where doubtful.

COMBINATION LANDSLIDE
Area of recent and old slides in which
individual slides are not identified.

COLLUVIAL SLOPE
Valley wall along major streams with slope as
steep as 40° (85%); stony, clayey silt soil up
to 50 ft. (15 m) thick; commonly buttressed by
a terrace or bench at the toe of the slope; very
susceptible to sliding by cutting of toe area,
removal of terrace or bench, and overloading;
slide commonly activated without apparent cause.

SCREE
Residual accumulations of coarse rock material
lying on quartzite slopes of the Valley and
Ridge province. Generally stable except where
subjected to extreme rainfall.

COLLUVIAL SLOPES WITH LANDSLIDES
Landslides too small or obscure to map
individually.

**AREAS SUSCEPTIBLE TO DEBRIS FLOWS AND DEBRIS
AVALANCHES**
Primarily shallow, narrow ravines and chutes with
accumulation of stone colluvium generally 10 ft.
(3 m) or less in thickness; susceptible to rapid
movement during intense rainfall. Most ravines
and chutes designated show evidence of former
debris flows and avalanches. Symbol & design-
ates historical debris flow or debris avalanche.

AREAS SUSCEPTIBLE TO ROCKFALL
Steep, locally vertical, natural and man-made
slopes and cliffs, 15 ft. (4.5 m) or more high;
formed dominantly of sandstone, limestone, sandy
shale, mudstone and claystone. Interbedded mud-
stone, claystone and shale weather rapidly leaving
sandstone and limestone rock faces unsupported.

SOIL AND ROCK SUSCEPTIBLE TO LANDSLIDING
Soil and rock similar to that involved in land-
slides elsewhere in map area; primarily areas
underlain by claystone, mudstone and shale
associated with other rock types. Rock weathers
rapidly on exposure forming clayey soil highly
susceptible to sliding. Includes coves (U-shaped,
shallow valleys) containing thick layers of clayey
soil that are very susceptible to sliding where
excavation breaks continuity of slope and where
overloaded by artificial fill.

AREAS LEAST PRONE TO LANDSLIDES
Map areas in which no patterns or symbols are shown;
primarily valley floors, ridge tops and broad
benches; modification by excavation and fill may
lead to local landslides.
Includes slopes where landslides are sparse.
